Preliminary Assessment
of the
Mary Washington House Kitchen
Historic Structure Report

Historic Structure Report

Mary Washington House Kitchen

December 2010

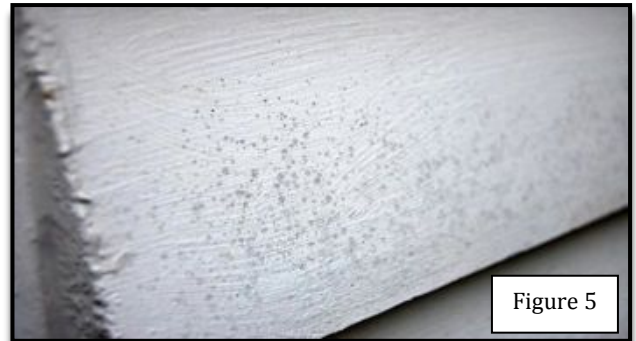
On the eastern wall, there is evidence of black mold beginning at the lowest board and extending up approximately three feet. See Figure 5.

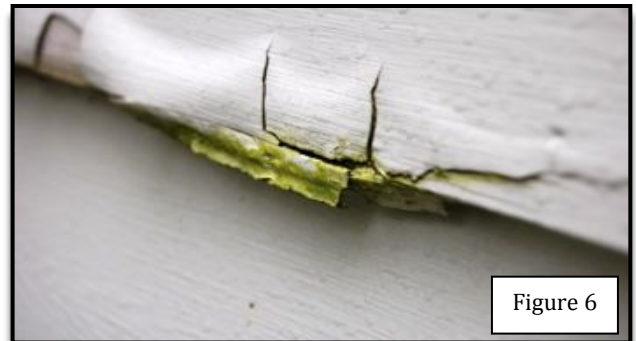
Along the lower portion of the northern, gable end there is clear evidence of mildew and mold. Green mildew covers much of the lower portion on this exterior wall. See Figure 6.

Another concern which primarily affects the preservation of the northern wall and the roof on the western side, involves the overhanging crape myrtle trees near the structure. The sprinkler facing the northern gable end contributes to the growing mildew issue on that wall but the large trees near the kitchen may also heighten the dampness of the area. The shade created by the tree prevents the quick evaporation of water from the area, which perpetuates the growth of mildew and mold. A mild trimming of the large crape myrtle branches may alleviate the moisture problem while still preserving the visual integrity of the landscape. In order to remove the mildew from the northern wall, a mild concentration of bleach (1:10) with water may help remove the mildew.

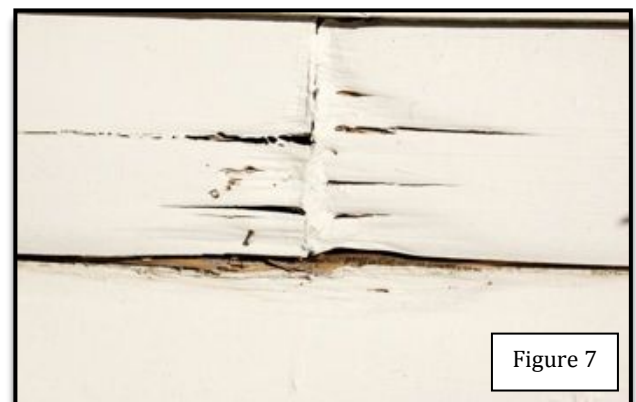
Certain portions of the western wall show evidence of rot underneath the latex paint. There is less observable mold but the lower pieces of weatherboard are soft to the touch. See Figure 7.

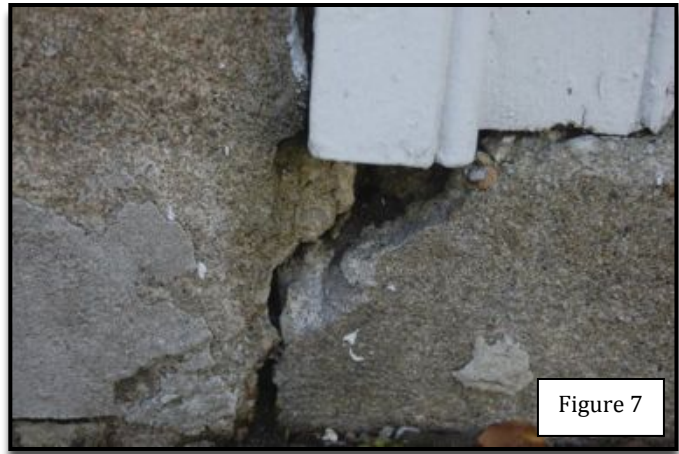
Figure 7

The concrete foundation which supports the overlying timber structure shows signs of isolated cracking in different areas. There is evidence of previous remediation efforts to fill in the cracks. One of the more noticeable foundation cracks is found on the eastern wall below the left side of the door jamb. Despite the cracking, the deterioration of this rigid material does not pose a major threat to the stability of the structure.

The impervious concrete foundation is a relatively unforgiving material and poses a preservation concern with the wood members which rest atop it. The concrete does not allow for the passage of water which accelerates the deterioration of the wooden sill. Rain water collects on top of the concrete foundation as the water travels down the side of the building. The water stagnates on the surface of the foundation and the wood members directly above it collect water and over-saturates to a level which promotes rotting and other decay.

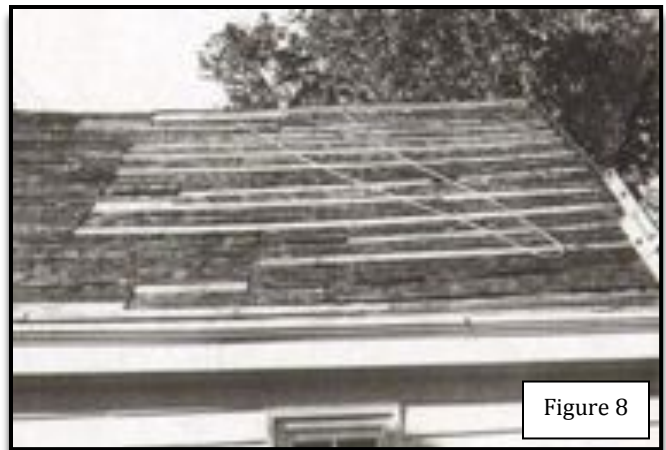
No testing was performed on the roof but there are no visible signs of decay. The roof shingles were replaced in 2005 and presently they retain a grayish tan color. Figure 8 shows the exposed roof just before the new shingles were placed on top 5 years ago.

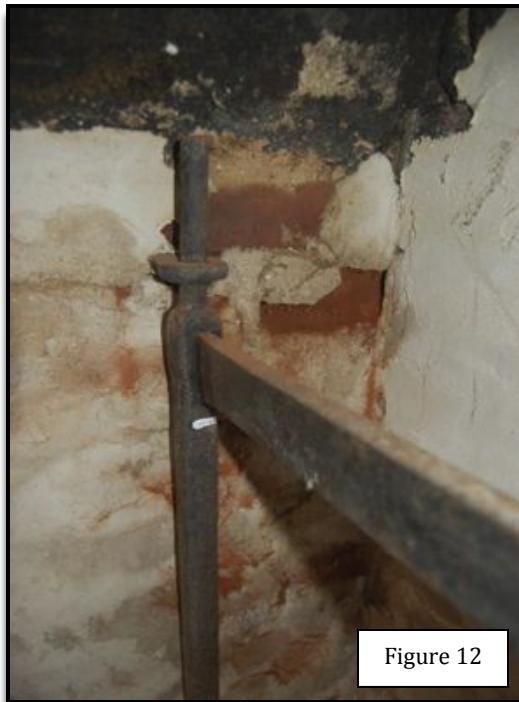
Figure 11 shows evidence of spalling within the fireplace and Figure 12 shows the amount of brick dust which has fallen through the crack.

In order to secure the stability of the chimney, it is suggested that the plaster surrounding the hearth be removed. Since there is evidence of deteriorated and weakened bricks beneath the plaster, replacement of these bricks should be expected. Before undertaking any future remediation efforts with the chimney, necessary structural restraints should be placed to avoid unintended structural collapse.

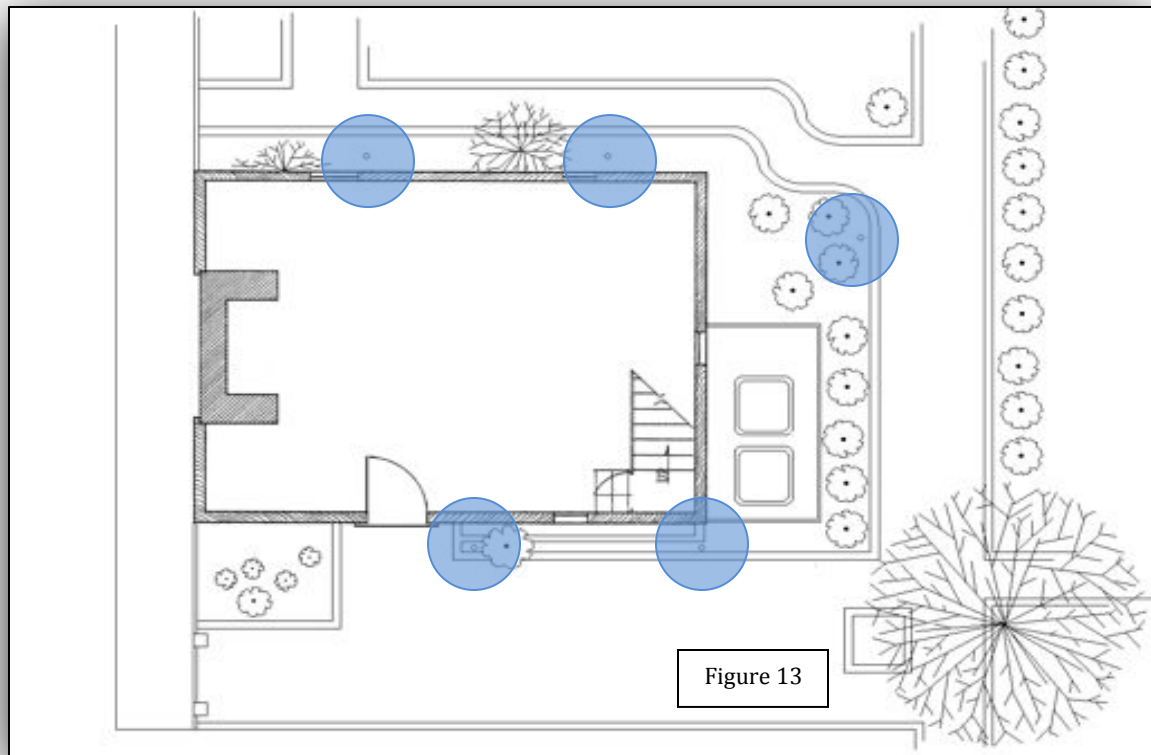
One of the possible causes of the accelerated deterioration to the lower weatherboard stems from the automated sprinkler system close to the building. The strip of vegetation between the brick walkway and the building requires minimal watering and the current watering system over saturates the area and splashes the side of the building.

Figure 13 outlines the sprinklers in use around the kitchen. Apart from the sprinkler on the northern end of the building, all the other sprinklers are less than a foot and a half away from the structure. Figure 14 and 15 show evidence of the aggressive watering system.

Therefore in an effort to better preserve the structure and reduce water consumption and costs, it is suggested that the sprinkler zone around the kitchen be permanently switched off. Hand watering the bushes and flowers around the kitchen will reduce the amount of water exposure to the structure and may curb the proliferation of rot, mildew, and mold to the weatherboard.

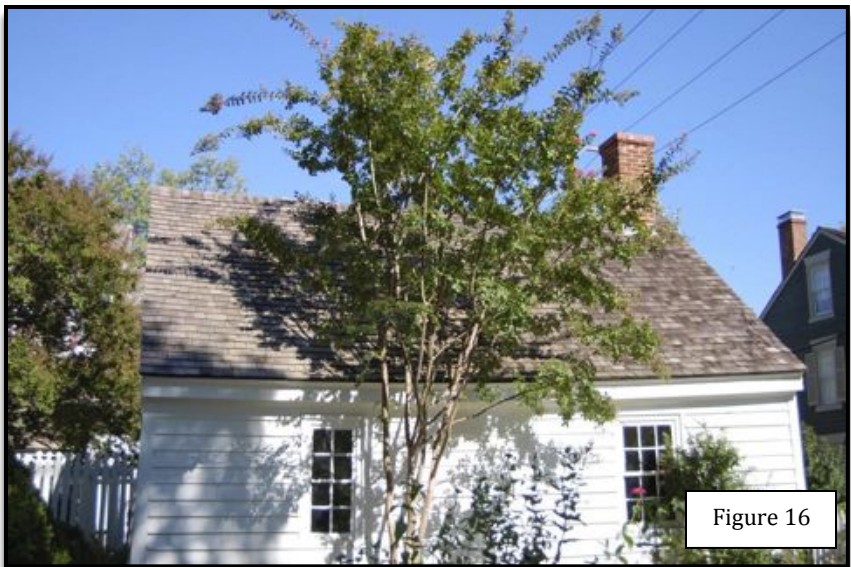
The tree abutting the western wall may pose a series threat to the preservation of the roof. Its foliage covers a significant amount of the roof and creates the potential of trapping moisture and preventing the wooden shingles from adequately drying. See figure 16.
