STRATFORD HALL PLANTATION

A Survey of the Architectural Landscape

Stratford Plantation Landscape

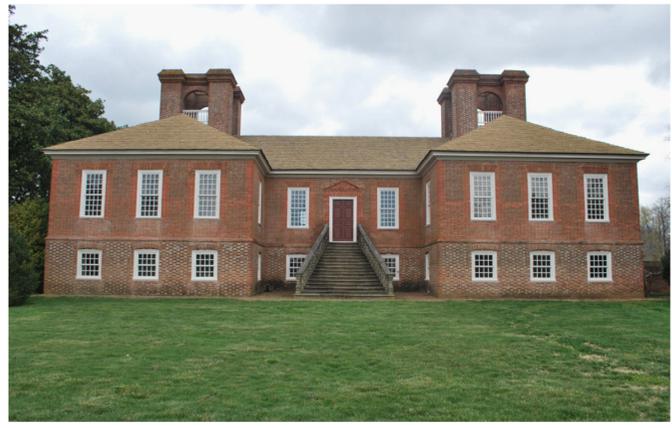
Stratford Hall Plantation, Main House

Stratford Hall Plantation is an 18th-century plantation located in the Northern Neck of Virginia. Many changes have altered its architectural landscape through the years, most notably in a restoration of landscape, outbuildings, and plantation house stairs taking place circa 1930, by Fiske Kimball. The reconstructions made the entrances more dramatic and emphasized the importance of the main house.

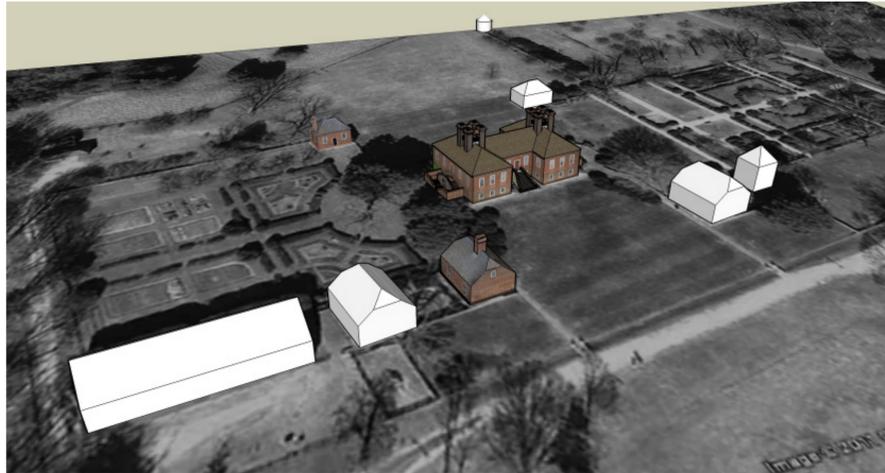
Stratford Hall Plantation Google SketchUp and Google Earth

We used the existing HABS drawings to render the main plantation house in Google Sketchup. We took Tachy-CAD and Total Station points of two outbuildings, rectified photographs of the two outbuildings within Photo-Plan, and utilized AutoCAD to gather the dimensions of the structures. We uploaded the resulting Google Sketchup models into Google Earth to more accurately present the landscape.

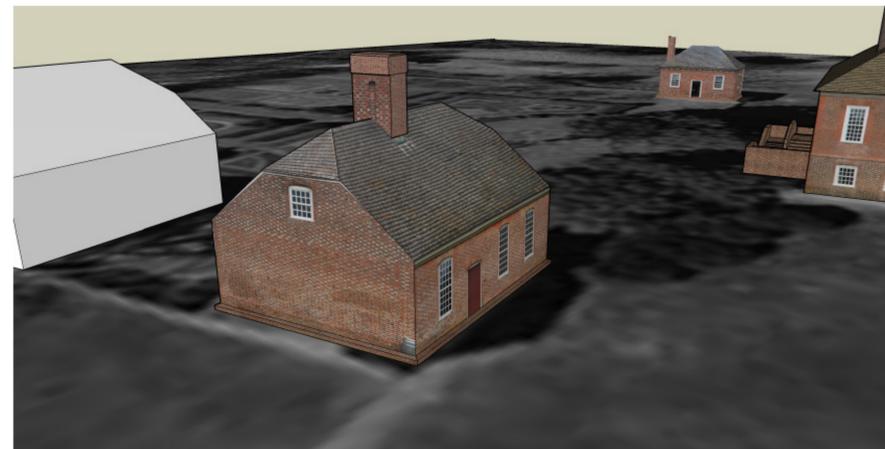
TachyCAD buildings are represented in brick, while other buildings are white

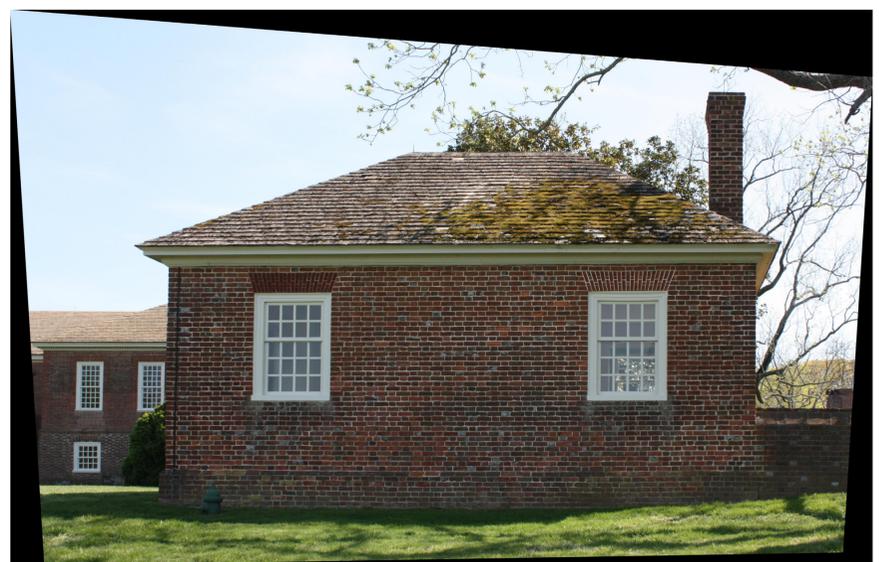
Original outbuilding, connected to landscaping wall

The original structures are closest to the main house. The structures include an overseer's office, garden storage, servants quarters and the kitchen. They are made of brick with two plans. They are largely unaltered, on the exterior, from the time of their construction. However, interior renovations have been necessary due to their age.

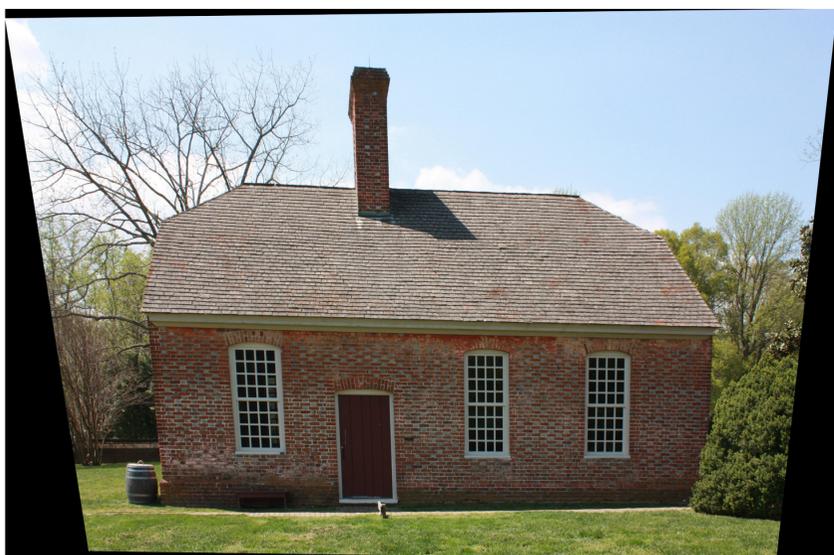
Reconstructed outbuilding

These structures used to serve a more specific function on the plantation, such as the stables, smokehouse and slaves quarters. These structures were used by slaves and servants, so they were the most likely to fall into disrepair when fewer people inhabited the plantation. The reconstructed structures are generally further away from the main house.
