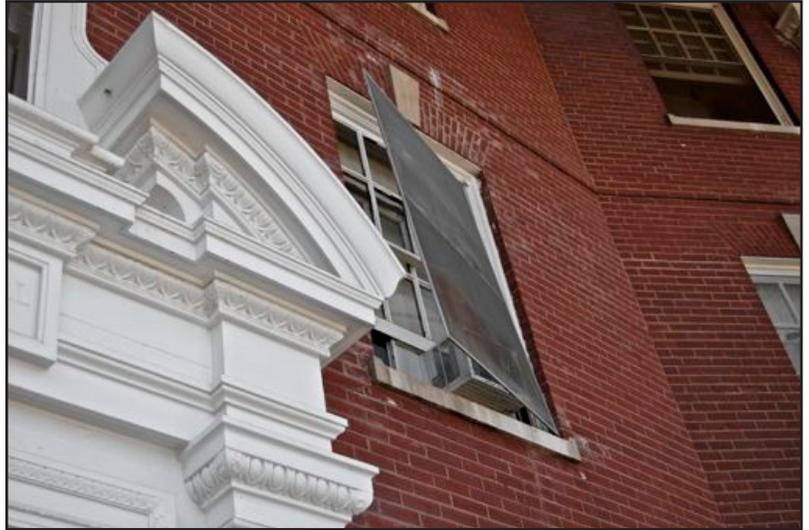
AC window unit improperly installed in Westmoreland Hall

Air conditioners are a main cause of window deterioration at the University of Mary Washington. Even though this solution may be a less intrusive option to the historic building, steps need to be taken to ensure that these units do not disturb the historic integrity of the windows any longer. Currently the improper use of these units is causing irreversible damage to historic windows, because they are being installed, maintained, and removed incorrectly. Maintenance personnel need to be informed of proper ways of installing and removing the units through training sessions as to ensure that the proper ways are being upheld.

- If the air conditioner requires temporary removal, steps should be taken to preserve and protect the historic window sash and frame.

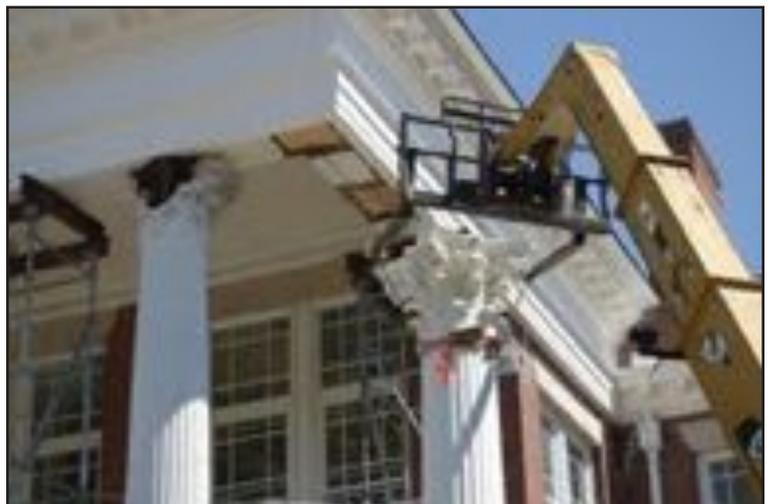
Fiberglass columns being fitted for Monroe Hall

Many renovation projects call for the removal of wooden features and promote the utilization of synthetic materials in lieu of natural materials. Synthetic materials such as fiberglass are advertised as green, low cost, and maintenance free. However, synthetic materials fade and if damaged, tend to require large, costly replacement pieces. Although materials like fiberglass have some attractive qualities, retrofitting these materials into historic buildings irrevocably mar the buildings' historic integrity and feel. Therefore, the incorporation of synthetic materials should be discouraged. Wood has withstood the test of time and if properly maintained is still a viable and cost effective material.

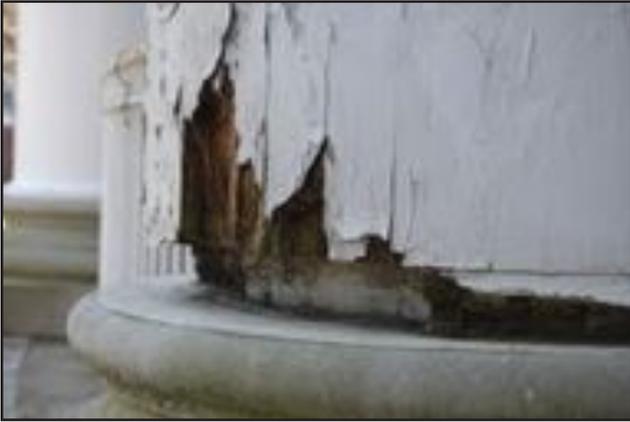
Base of a column with wood deterioration

Repair to the wood often involves replacement of rotted features. In most cases though, it does not require replacement of the entire wood member or feature. Most of the time, areas affected by rot are isolated which necessitates limited removal of rotted sections.

- Repair to wood should match the profile of the existing feature and when possible, the replacement wood should be taken from the same type of tree.
- Even rotten wood does not always require removal. Epoxies can restore the strength of the wood and prevent the removal of the piece. This remediation effort should be guided by a preservation specialist to ensure proper application. Improper remediation efforts can exacerbate the issue plaguing the wood.

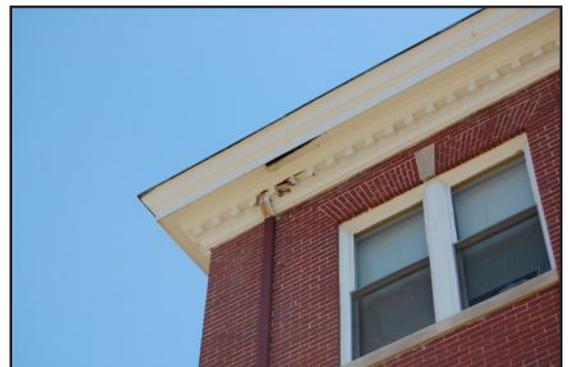
Damage to the cornice of Virginia Hall near gutter spout

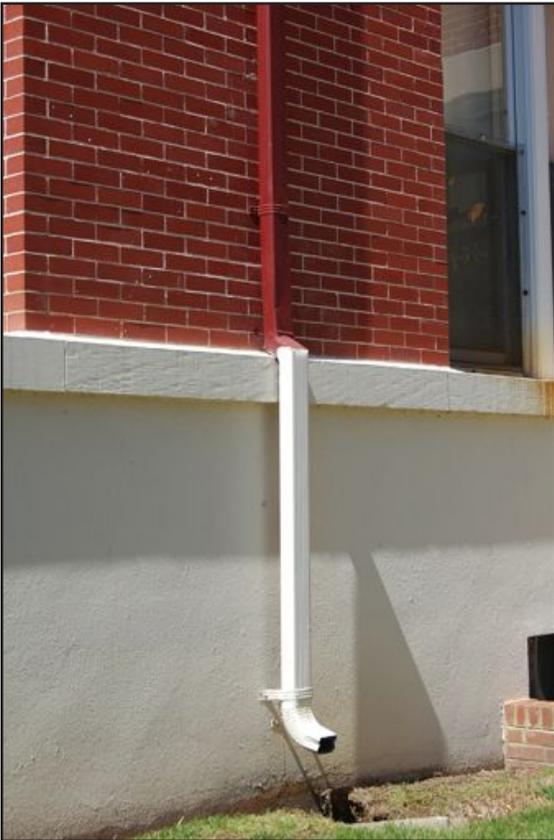
Downspout, Virginia Hall

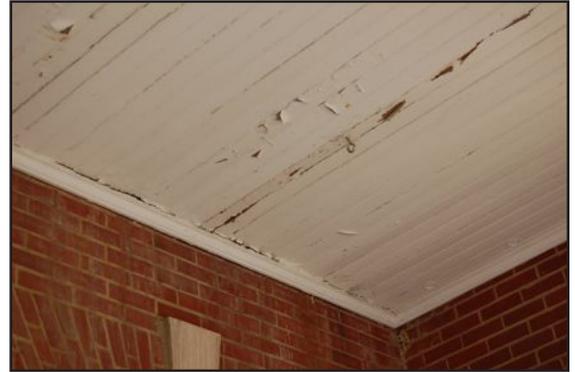
Top: Ceiling neglect in Westmoreland Hall porch  
Bottom: Westmoreland Hall side entrance

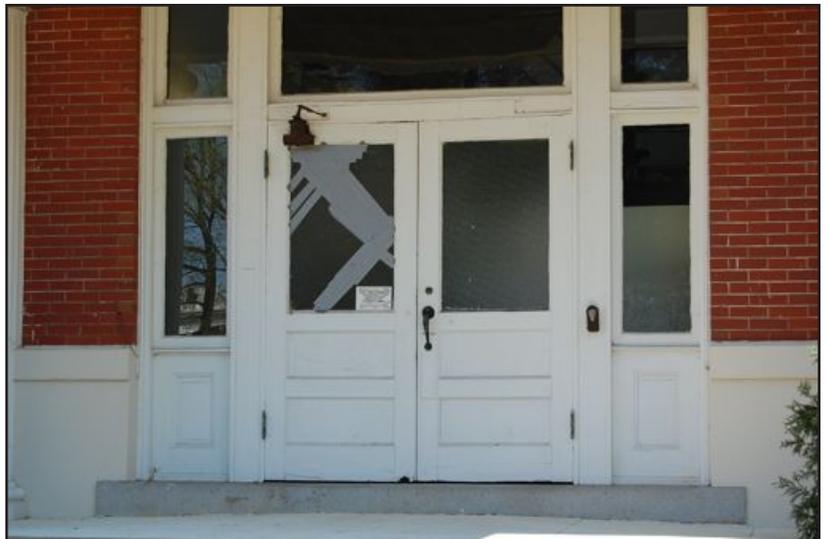
Broken windows at Virginia Hall
