Preliminary Assessment
of the
Mary Washington House Kitchen
Historic Structure Report

Historic Structure Report

Mary Washington House Kitchen

December 2010

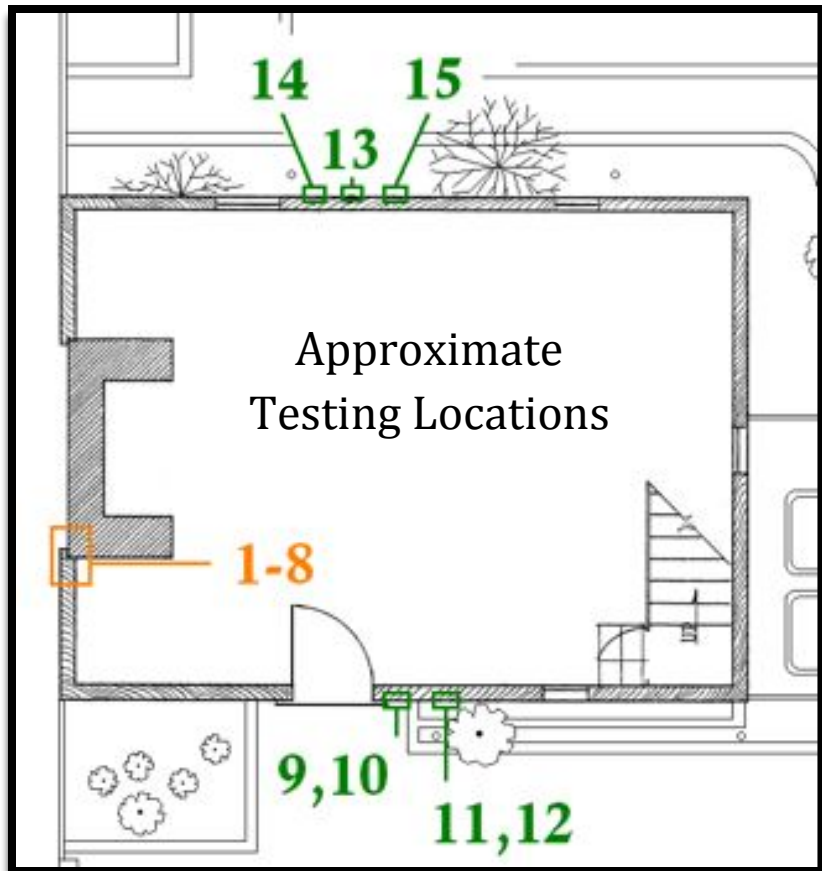
Testing Log

Testing with the moisture meter provided further evidence of wood deterioration below the surface. The tests 9 through 15 utilized the moisture meter and yielded varied results.

The moisture meter can read moisture levels up to 40%; therefore, there is no way to determine the exact percentage above that limit. Tests 13 and 14 recorded moisture readings of 40%. Test 15 had readings closer to 10% but Test 15 taken from weatherboard 30" from the ground whereas Test 13 and 14 were taken from 20" and 15" from the ground, respectively. Tests 11 and 12 had high readings similar to the western wall. Test 9 and 10 were both taken 6.5" to the right of the door jamb. However Test 9, which was taken 5" lower to the ground than Test 10, had readings close to 30%, nearly double the moisture percentages for Test 10.

Most of the weatherboard close to the ground recorded high levels of water saturation. Although the tests were taken during a relatively wet week, the rain still should not have augmented the readings to 40%.
